Navajo Abandoned Uranium Mine

Site Screen Report

Cov192 AUM Site

Navajo AUM Northern Region

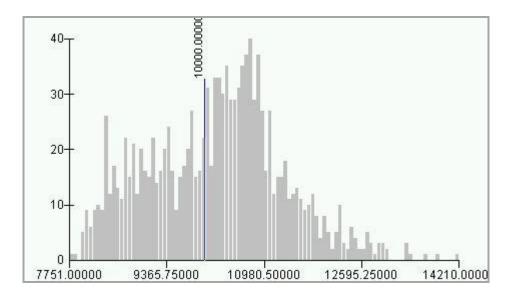
A total of 1,242 gamma radiation measurements were collected from the mine site, ranging from 7,751 cpm to 14,210 cpm. The majority of the site was inaccessible due to steep grades. The measurements are represented in Figures 1 and 2.
